Manhole Inspection Summary

Manhole # **S13GG_012MH**

Insp Date: **2/23/09 11:17 AM**

Location Address: **REAR OF 2814 BAKER ST**

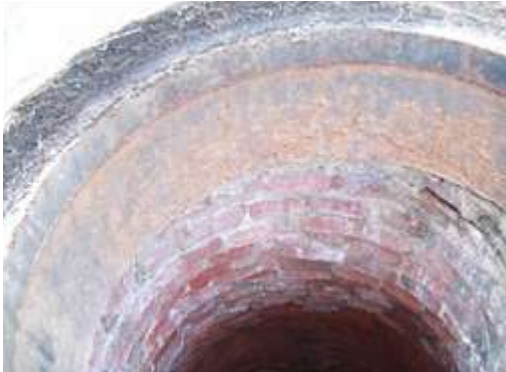
Defect 3

Infiltration: ☐ None ☐ Joint ☒ **Cracks** ☐ Mortar ☐ Roots ☐ Wall

INFILTRATION at cracks

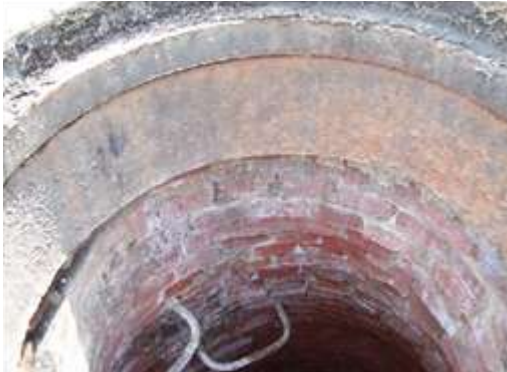
Defect 2

Condition: ☐ Sound ☐ Cracked ☒ **Root Intrusion** ☒ **Loose Brick** ☐ Deteriorated

chimney root intrusion and loose bricks

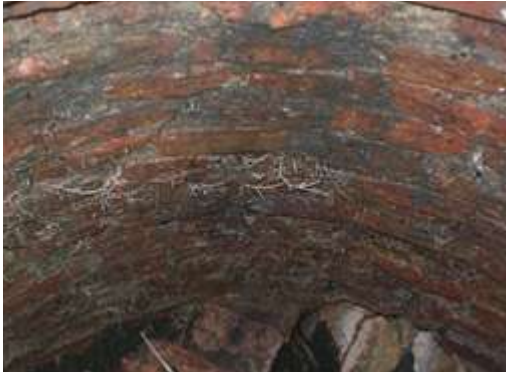
Defect 4

Condition: ☐ Sound ☐ Cracked ☒ **Root Intrusion** ☐ Loose Brick ☐ Deteriorated

ROOTS INFILTRATION

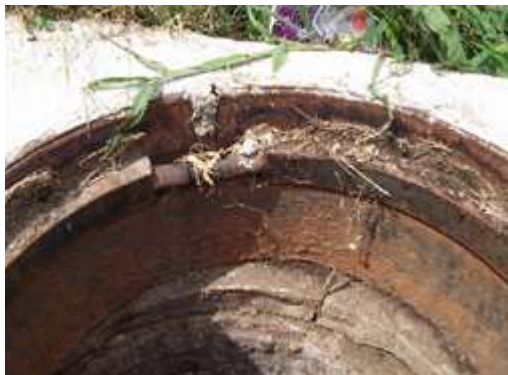
Defect 1

Infiltration: ☐ None ☒ **Joint** ☐ Cracks ☐ Mortar ☐ Roots ☐ Wall

infiltration at joint

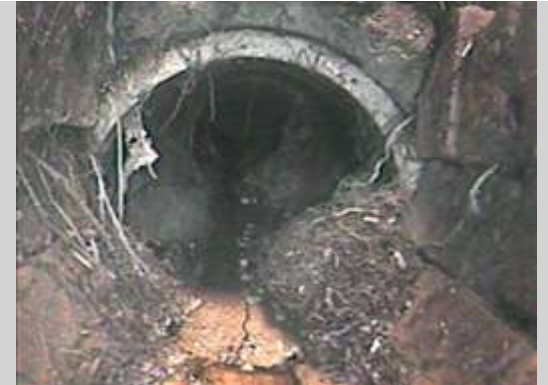
12 O'Clock Outflow

Pipe Height: (in.) Direct
Pipe Material: **Clay** ☐ Pipe Lined
Invert Depth: **7.75** (ft.) Flow Characteristics: **None**
Deposits: ☐ None ☐ Mud ☐ Sludge ☒ **Debris** ☐ Grease
Silt Depth: **2** (in.) Deposits Extent: **Light**
Infiltration: **Evidence** Pipe Seal Cond: **Roots**

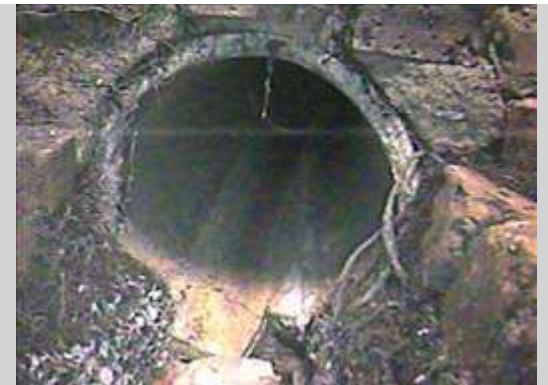
6 O'Clock Inflow

Pipe Height: (in.) Direct
Pipe Material: **Clay** ☐ Pipe Lined
Invert Depth: **5.92** (ft.) Flow Characteristics: **None**
Deposits: ☒ **None** ☐ Mud ☐ Sludge ☐ Debris ☐ Grease
Silt Depth: (in.) Deposits Extent:
Infiltration: **None** Pipe Seal Cond: **Roots**
